PRELIMINARY
KNKT.13.04.09.04

Aircraft Accident Investigation Report

**PT. Lion Mentari Airlines (Lion Air)
Boeing 737 - 800; PK-LKS
Ngurah Rai International Airport, Bali
Republic of Indonesia
13 April 2013**

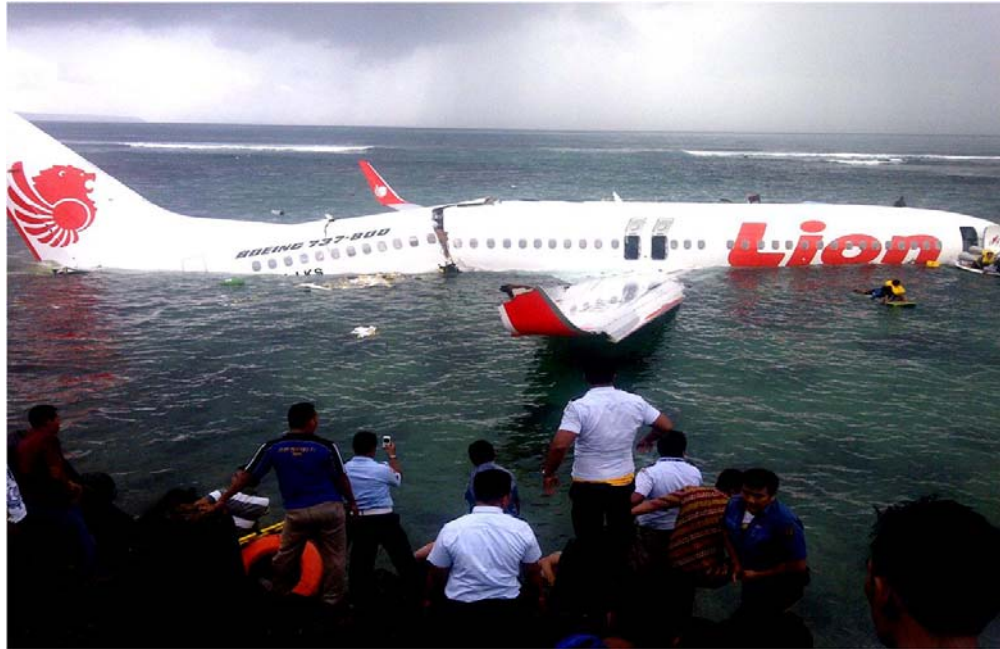
Figure 1: The aircraft after the accident

The aircraft was substantially damaged and submerged in shallow water.

The initial photographs revealed that the vertical stabilizer, right stabilizer, wings and control surfaces were in good condition with minimal damage. The right engine and both main landing gear had detached from the main wreckage.

All of the observed damage was consistent with post-accident contact with the sea floor, coral reef and sea wall.

In the period while the NTSC investigators travelled to the accident site approximately 6 hours after the accident, the degree of damage to the aircraft had worsened due to the environment.

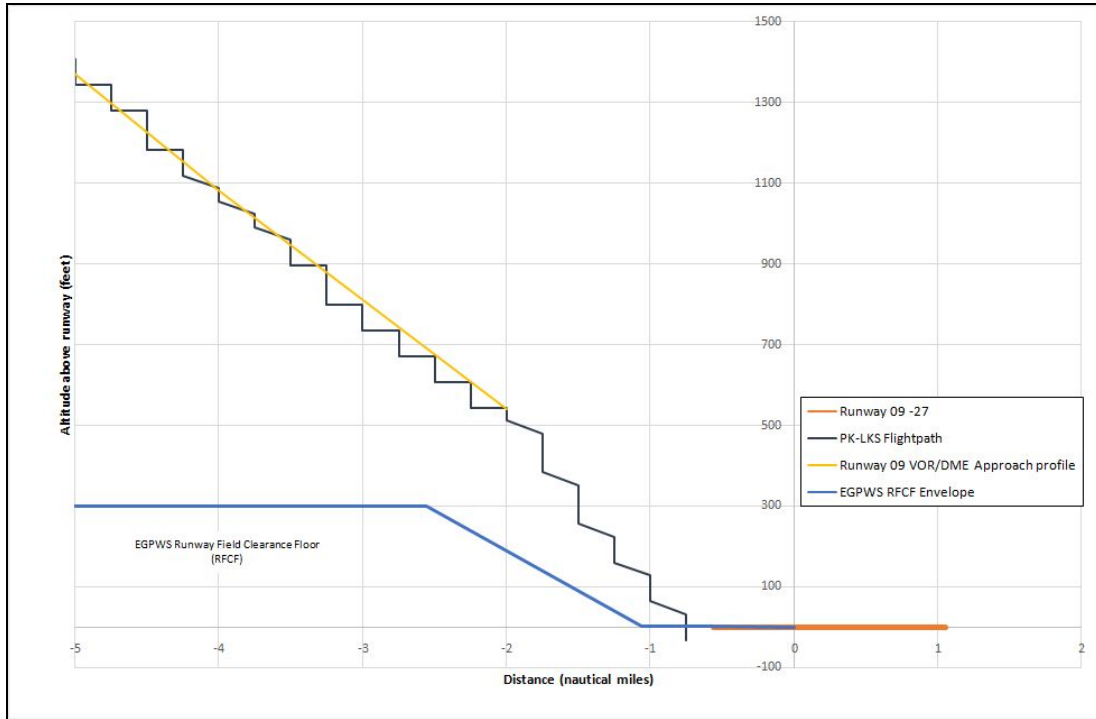
Figure 2: Aircraft flight path with respect to EGPWS envelope

Examination of the FDR and CVR information indicated that no EGPWS warnings occurred during the accident. Further examination of FDR data indicated that the aircraft did not enter the EGPWS alert/ warning envelope during the approach (Figure 2).

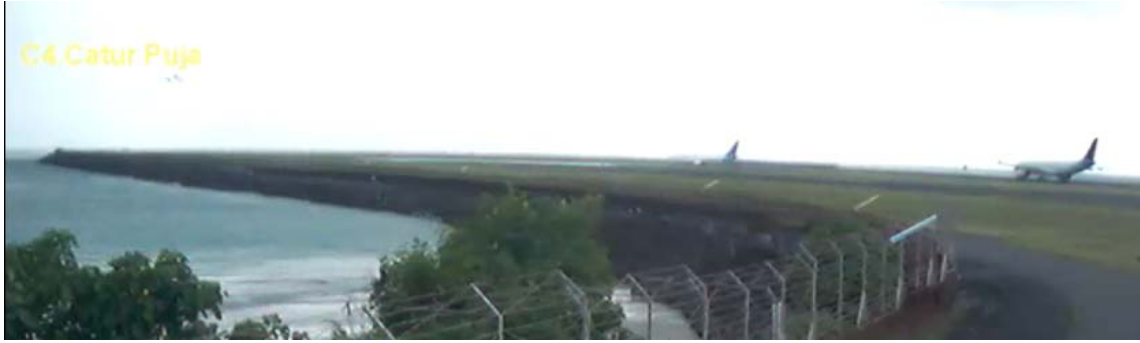
Figure 5: The weather 4 minutes prior to the accident

The airport Closed Circuit Television (CCTV) located on the south side of the runway recorded the weather changing. The rain showed as grey area on the left corner. The weather 4 minutes before the accident (Figure 5) showed the final area was clear.

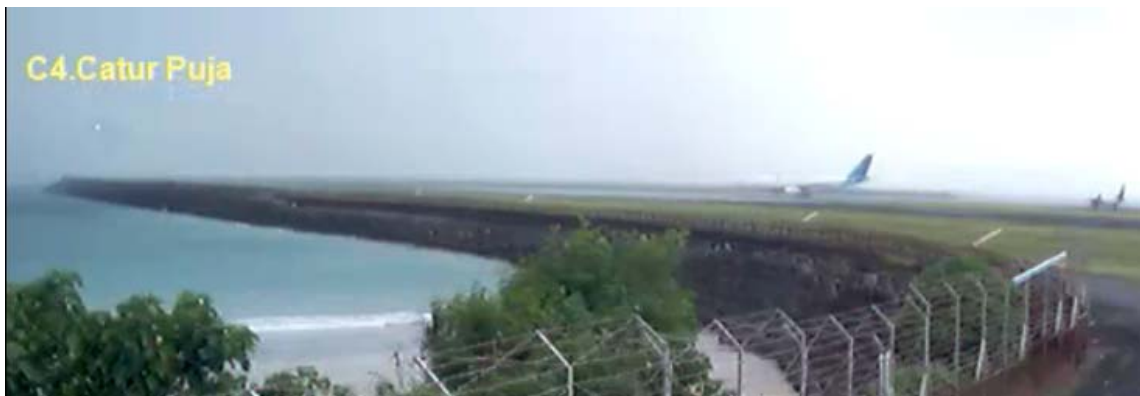
Figure 6: The weather few seconds prior to the accident

The weather few seconds prior to the accident on figure 6 showed the final area was raining.

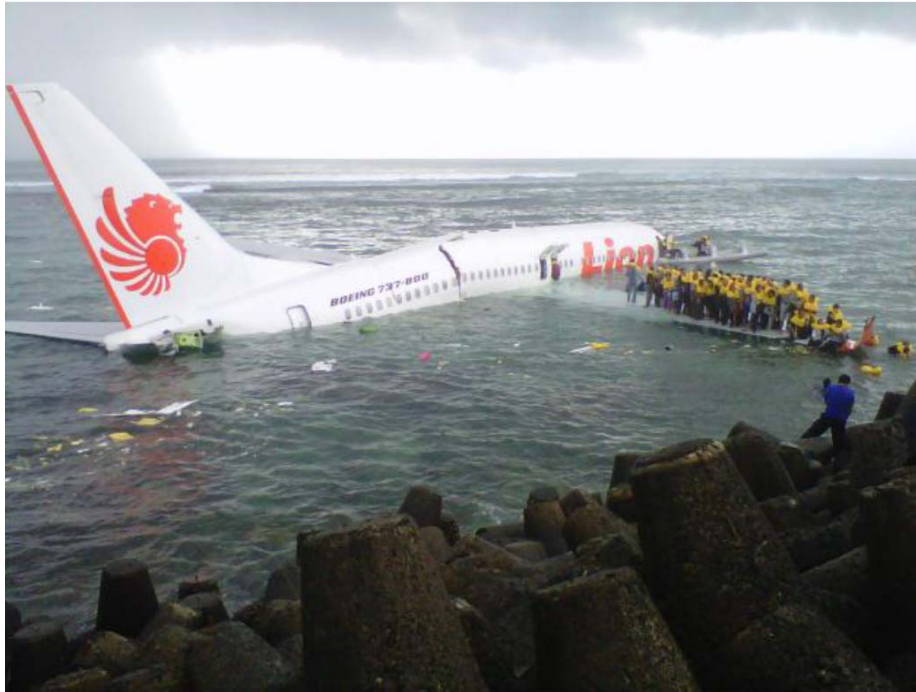
Figure 10: The evacuation process

The main cabin doors and escape hatches were all present and in the open position.

After the aircraft stopped, the water entered the aircraft cabin from the aft side and moved forward, the blowout panels on the flight deck door were broken.
